# STORM DRAIN INSPECTION REPORT FOR:

## **VA Northern California Healthcare System Alameda Point, CA**

March 8, 2016

Prepared by:  
**SANDIS**  
636 9<sup>th</sup> Street  
Oakland, CA 94607

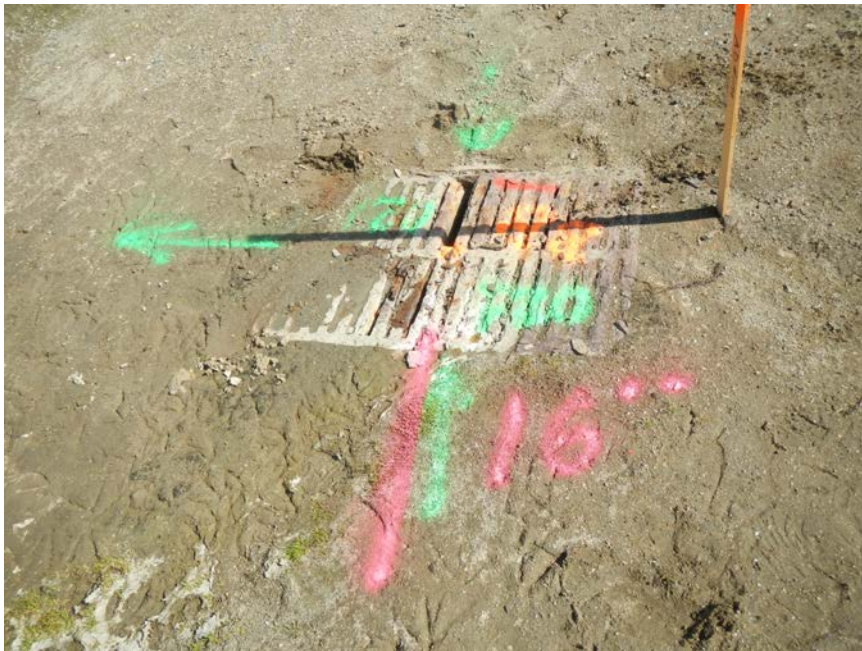
Structure: 7-21

- 1.) Rims on Catch Basins were rusted shut. Due to age and deterioration, several rims were inoperable and rusted shut to the frame of the inlet. To mitigate this condition, the rims would have to be forcefully removed which would likely break them so if this was attempted the owner should be prepared to replace the rims and/or catch basins if intended for future use. A photo of this condition is shown below.

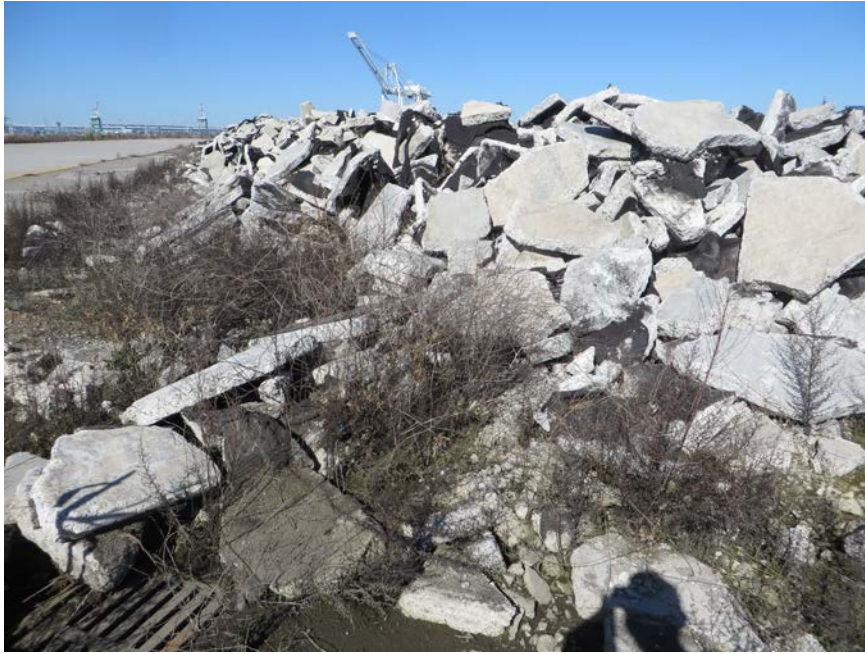
- 2.) Inlets or Manholes were buried or otherwise covered. In locations where inlets were expected to be, debris piles, trench plates, dirt, or overgrowth were present so the storm drain pipe could not be inspected. In cases where debris or other material can be removed or relocated it is possible that the inlets could be located and inspected but it is unlikely they would be found if buried. Photos of this condition are shown below.

Structure 2-10 shown. Structure 2-06 not located.

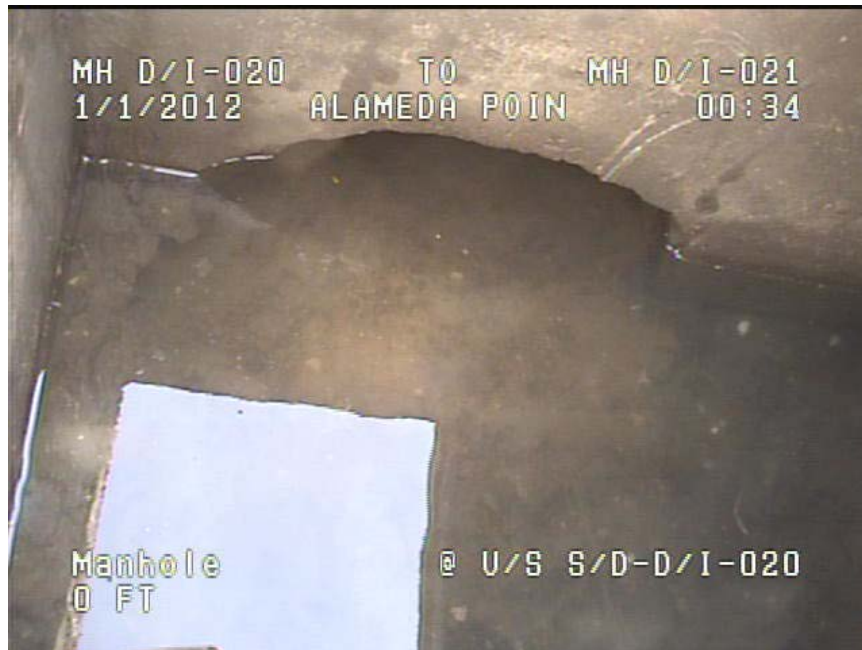
Subdynamic Survey (2016) – Structure 7-20 to 7-21

- 3.) High Water Level encountered in pipes. As mentioned previously, the work was timed with the low tide to best mitigate this issue. However, in several locations high water level prevented the completion of a portion or entirety of a storm drain pipe. It is possible that the pipes are clogged downstream and water is not being released which is creating this condition. To fix this issue, we recommend the water be pumped out and the pipe be cleaned or repaired as needed. A photo of this condition is shown below.

- 3) High Water Level in Pipe – Likely caused by downstream clogging. Water should be removed and the pipe re-inspected.
- 4) Surface Corrosion on Pipe – Corroded pipes are beyond their useful life and should be replaced. It is impossible to determine the remaining useful life that a corroded but otherwise structurally intact pipe will have. It is possible to prolong the use of the pipe using a pipe slip-lining technique in the short term.

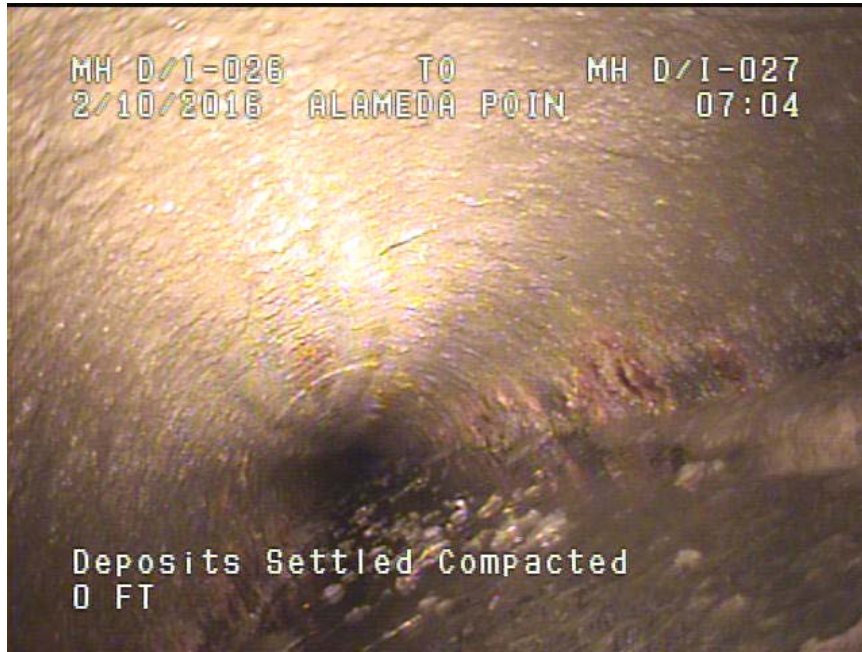
Subdynamic Survey (2016) – Structure 8-26 to 8-27

- 4.) Silt, Sediment, or Debris clogging pipe. This was the most common problem and prevented completion of the video inspection in the majority of the pipe on this site. This issue can be mitigated by hydrojetting or vacuum cleaning the pipes in order to re-attempt the video inspection. In some cases portions of the pipe may need to be physically removed in order to complete the video inspection. Photos of this condition are shown below and seen in the videos that were performed.

- 1) Sediment/Silt Buildup – This is a major defect for the functioning of the storm drain pipe system. If the pipes are to be reused, these pipes should be hydro-jetted or vacuum cleaned. As mentioned previously, due to environmental issues, hydrojetting may require collection of blown-out debris. Once pipe has been cleaned, the storm drain pipes should be re-inspected for any other potential structural issues.

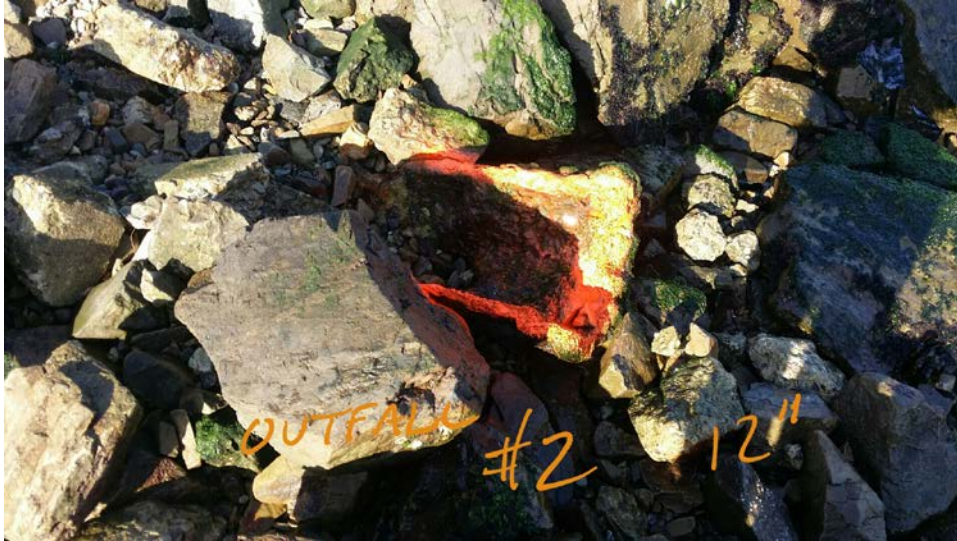
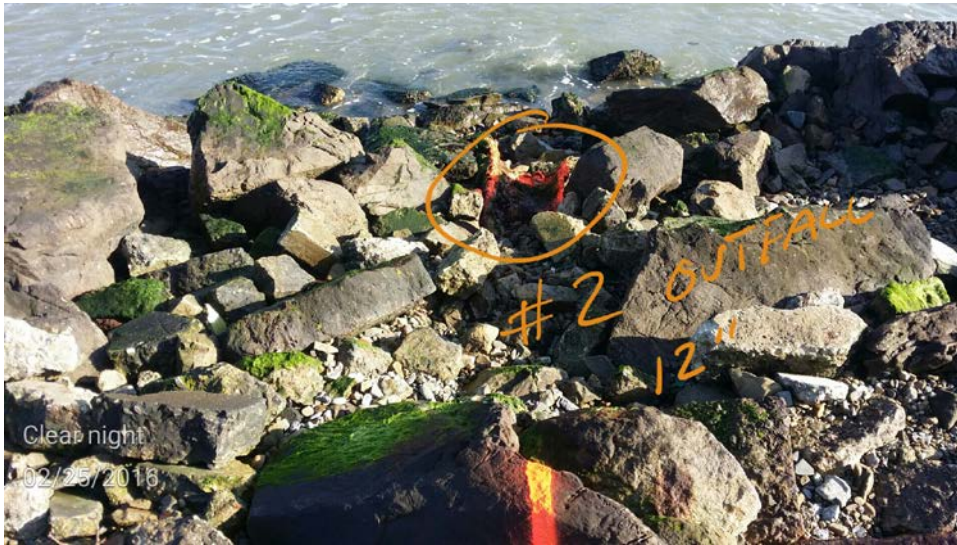
OUTFALL 2

Size and Material: 12" Corrugated Metal Pipe  
Condition: Bottom half of pipe found eroded and rusted. Rocks blocking outfall pipe upstream.  
Suitability for Reuse: Outfall is not suitable for reuse.

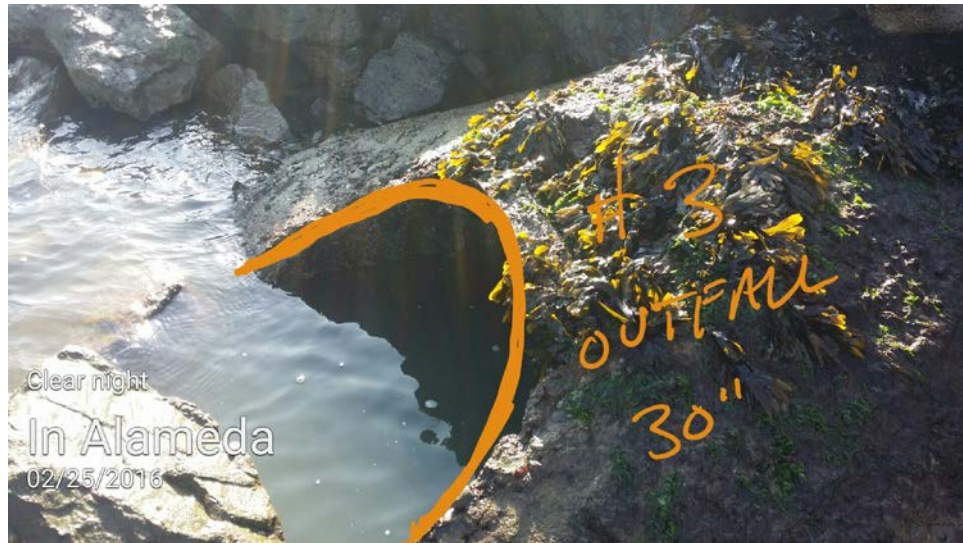
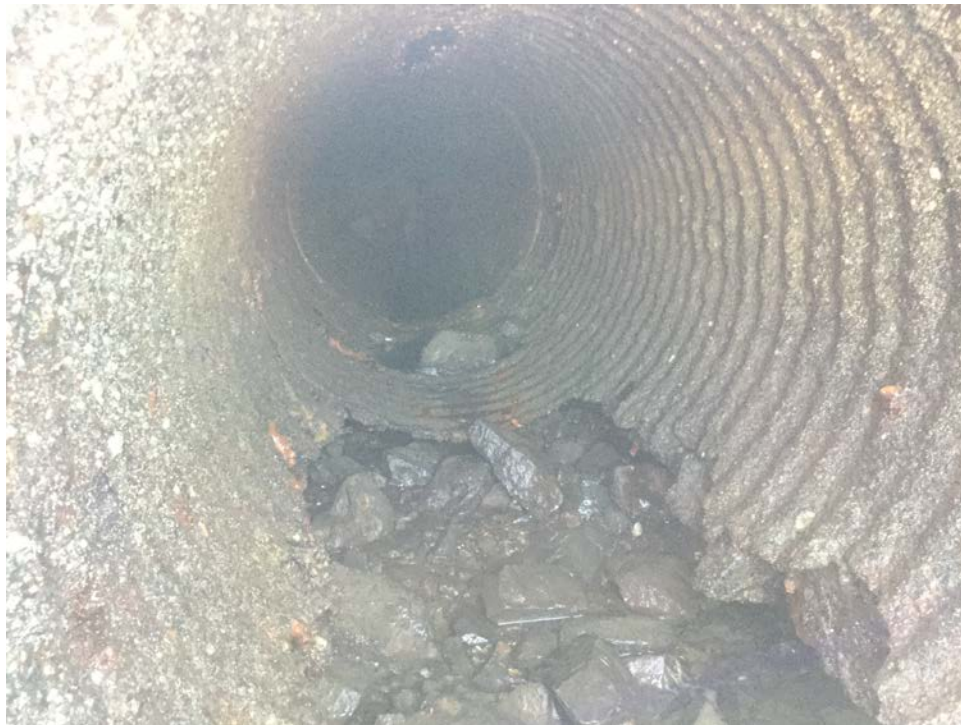
OUTFALL 3

30" Corrugated Metal Pipe (metal has corroded away)  
Metal pipe has corroded away near outfall and only the concrete encasement remains.

It is possible to connect to this outfall as it is still functional. The original pipe having eroded away would suggest reusing this structure would be a temporary condition, requiring rebuilding in the future.

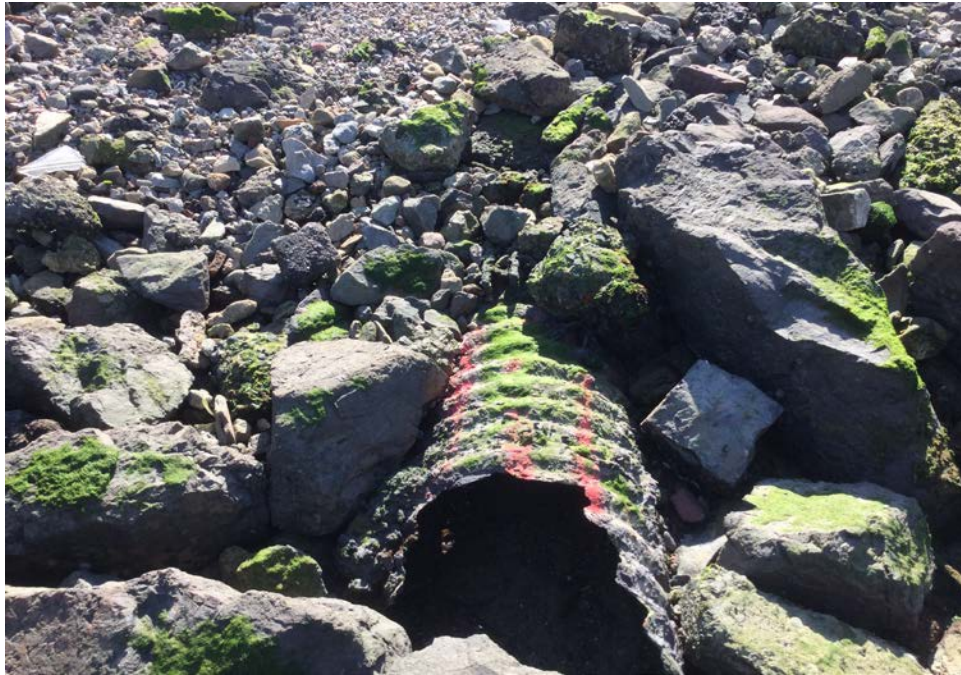
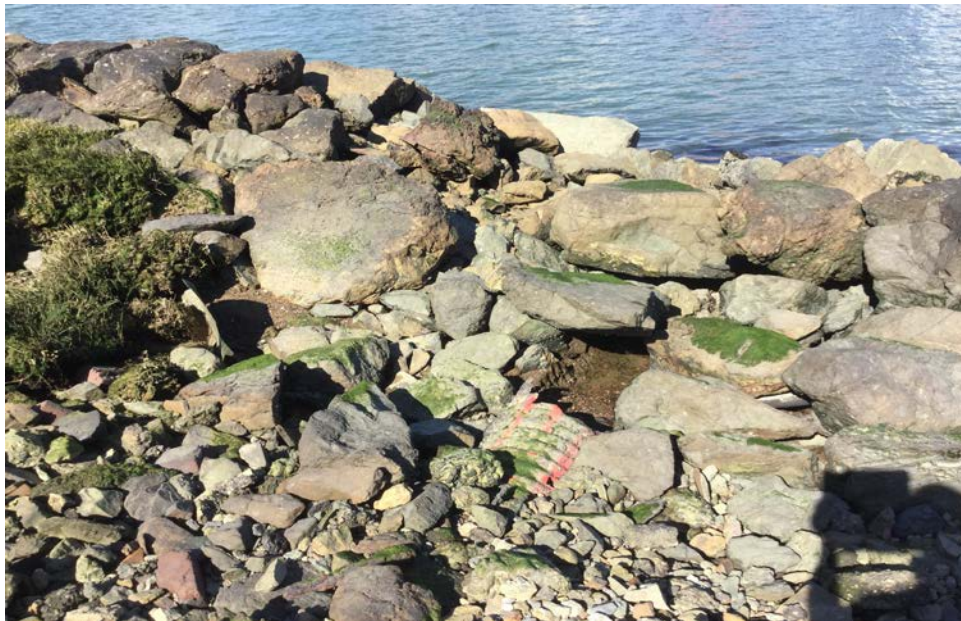
OUTFALL 5

Size and Material: 12" Corrugated Metal Pipe  
Condition: Metal has been corroded and rusted at outfall end. Pipe appears to be structurally intact.  
Suitability for Reuse: The outfall is missing a flap-gate, but may be a candidate for reuse in the short term. Recommend a long-term replacement option be investigated.

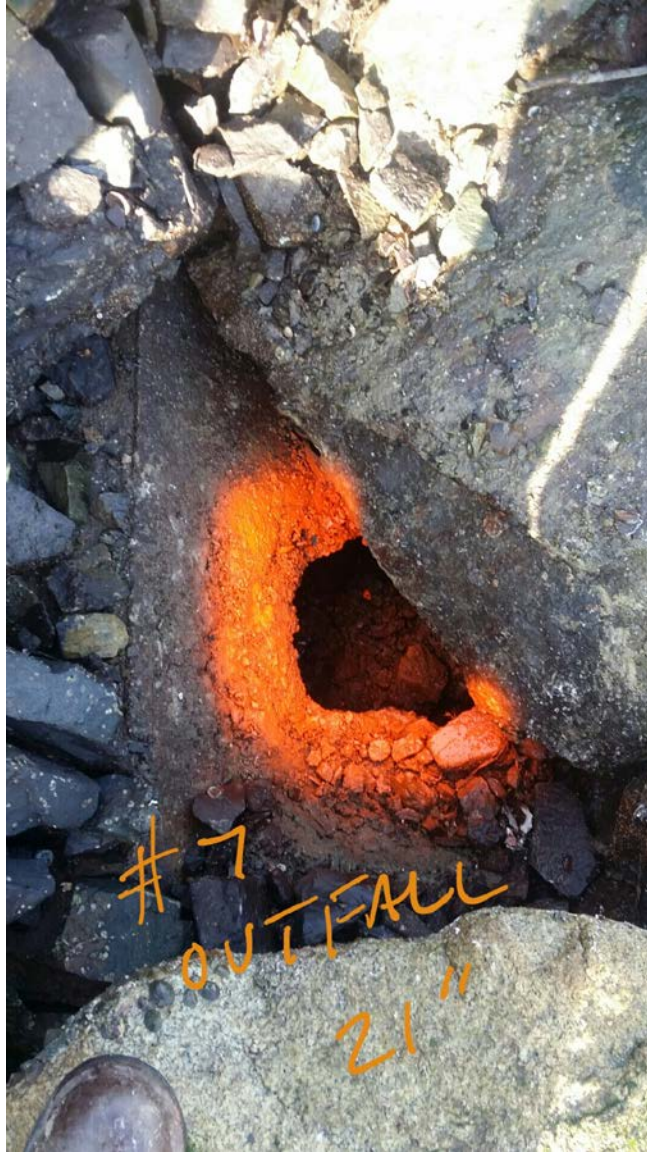
OUTFALL 7

The outfall contains debris and needs to be cleaned. There are several rocks that block the discharge point. There is no flap-gate present.

The headwall looks intact, therefore if the pipe is cleaned and inspected it is a possible candidate for reuse. Recommend the outlet point be cleared of obstructing rocks.

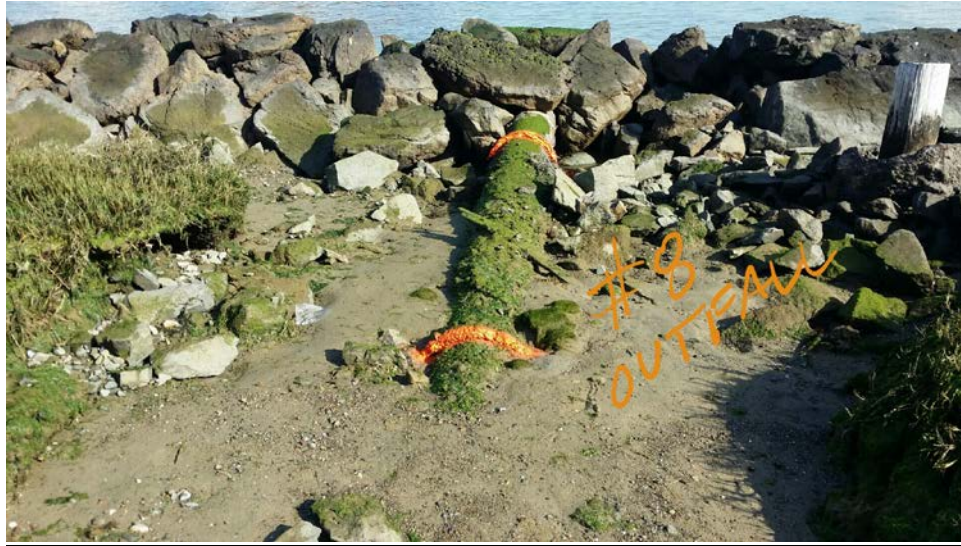
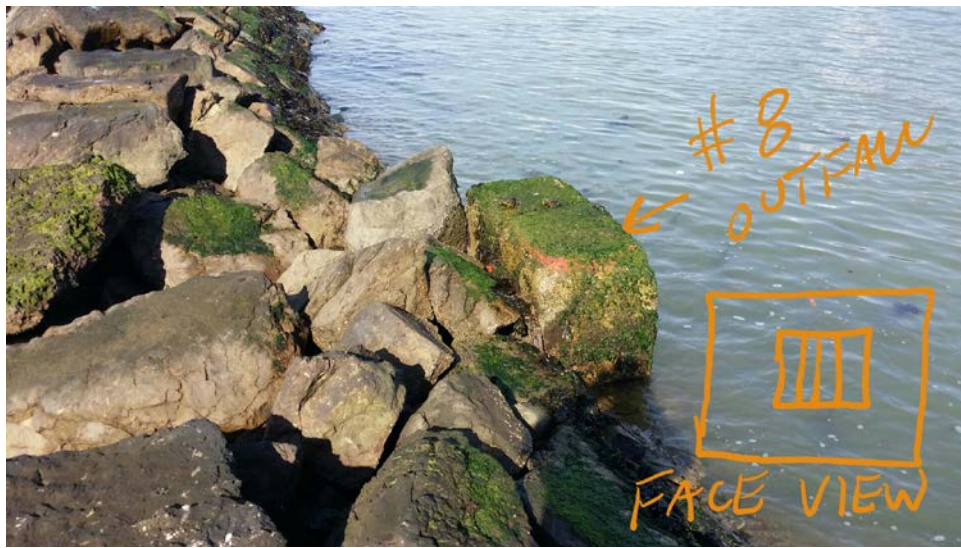
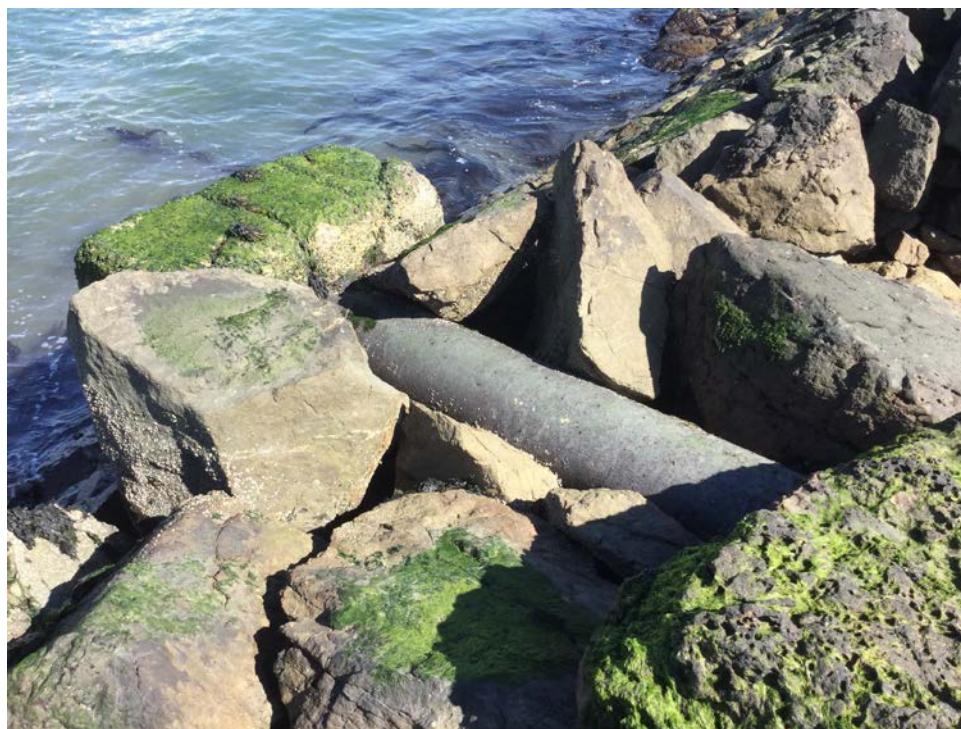
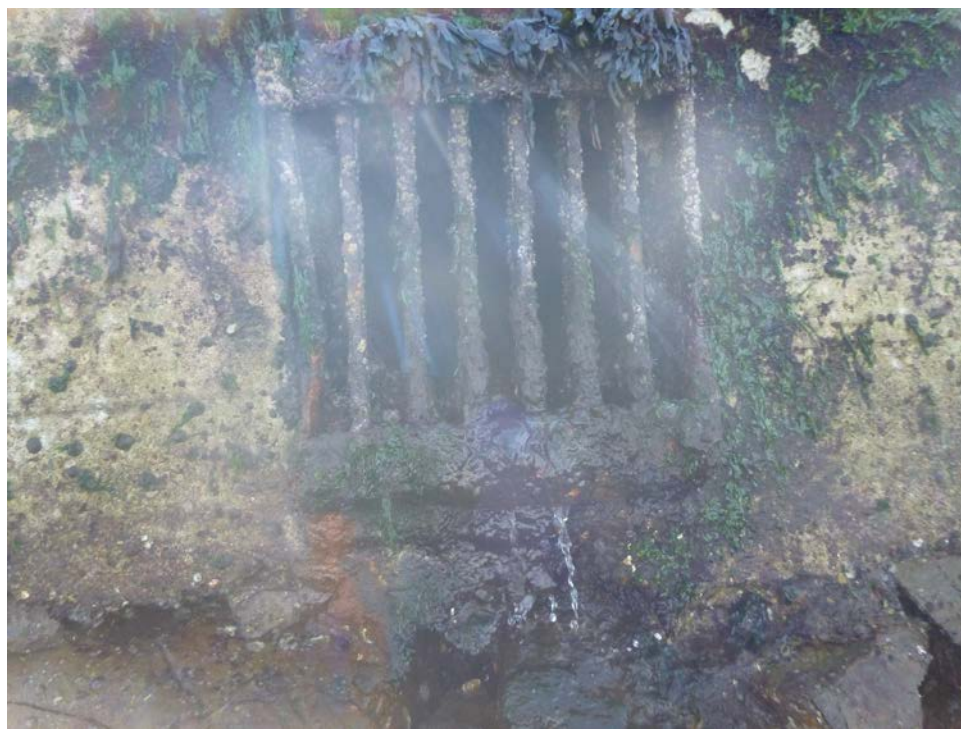
OUTFALL 8

Outside of pipe is corroded and rusted upstream from the outfall. Pipe looks to be replaced (less corroded) near the headwall. Pipe has a concrete headwall with metal grate at outfall end as seen in the photos below.

Outfall appears to be in sufficient shape to reuse. Corrosion of upstream pipe may limit useful pipe life.

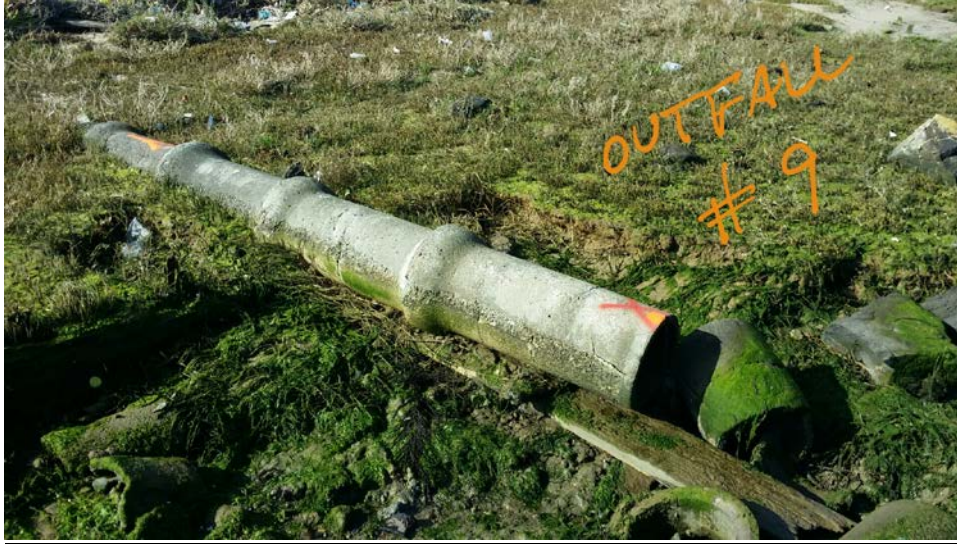
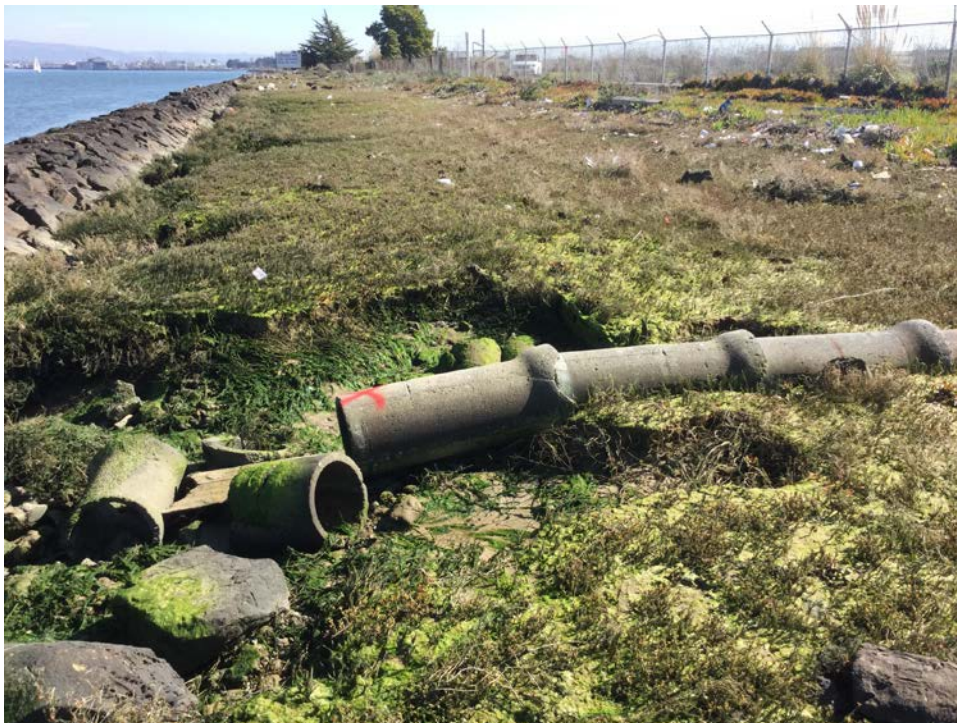
OUTFALL 9

Size and Material: 12" Reinforced Concrete Pipe  
Condition: Pipe ends short of rip-rap. Some pipe segments have fallen apart at the outlet, but the pipe itself appears to be structurally sound.  
Suitability for Reuse: Recommend extending pipe to rip-rap to consider reuse.

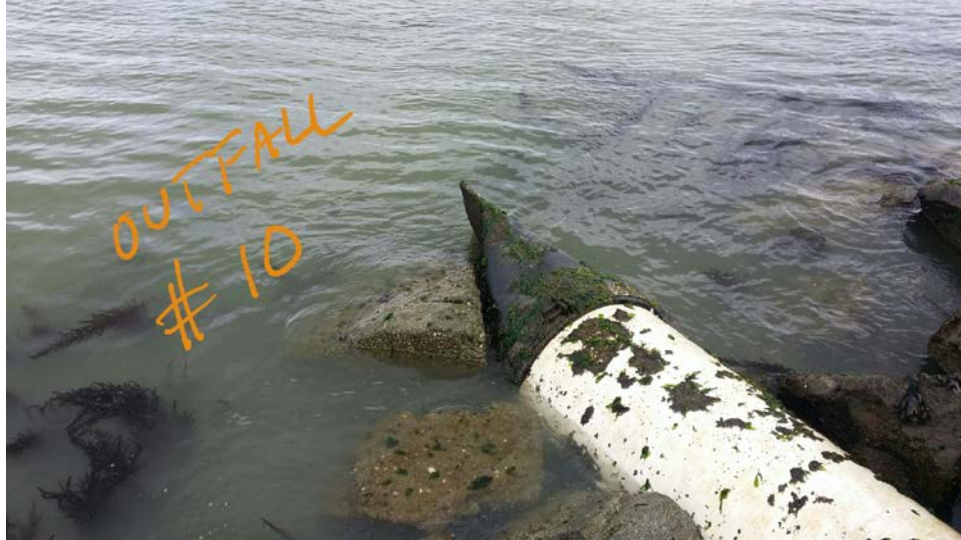
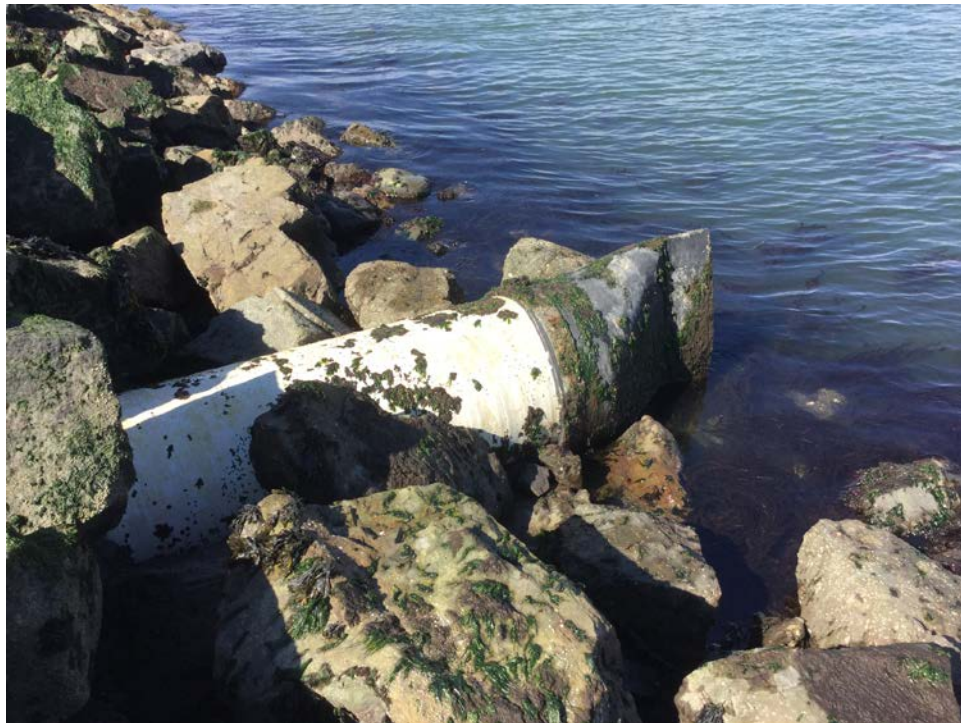
OUTFALL 10

Size and Material: 30" PVC  
Condition: PVC outfall is in good shape with rubber tideflex valve at end. There is a large rock that is on valve that would limit the ability to open, but otherwise appears functional.  
Suitability for Reuse: Suitable.

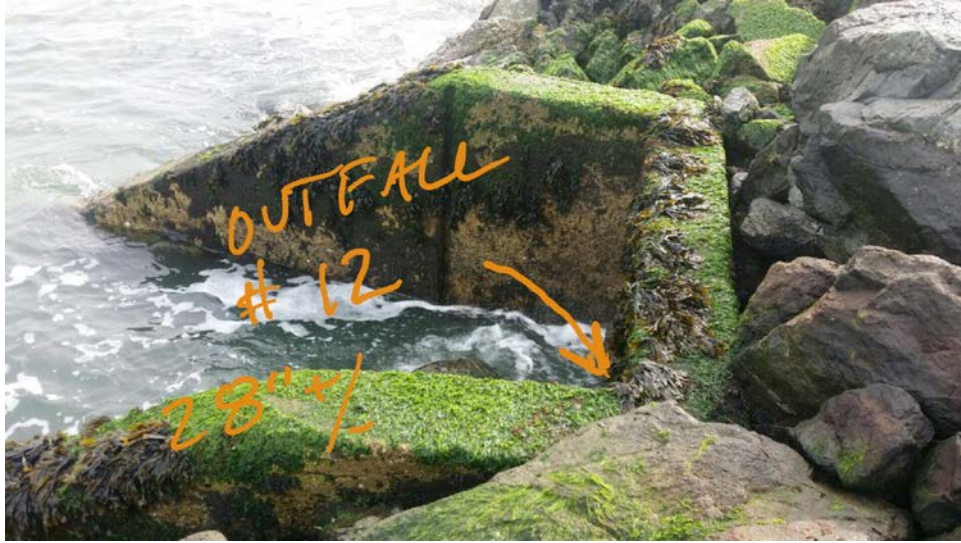
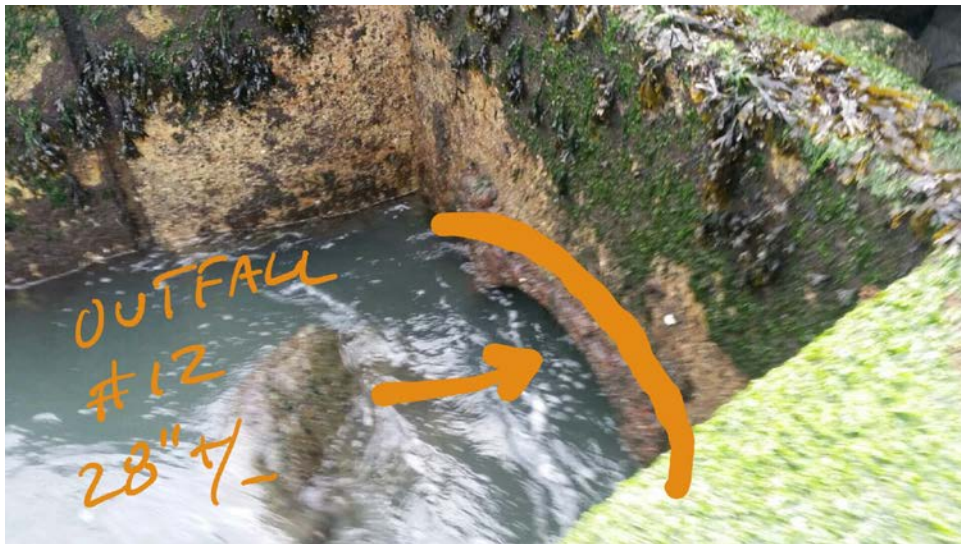
OUTFALL 12

Size and Material: 36" Reinforced Concrete Pipe  
Condition: Concrete headwall with no grate was found with rusted pipe end.  
Suitability for Reuse: Outfall appears to be structurally intact.  
Suitable.
