# WESTERN NEW YORK NATIONAL CEMETERY TRAFFIC ANALYSIS AND SAFETY STUDY

TOWN OF PEMBROKE  
GENESEE COUNTY, NEW YORK

**21 June 2022 Final**

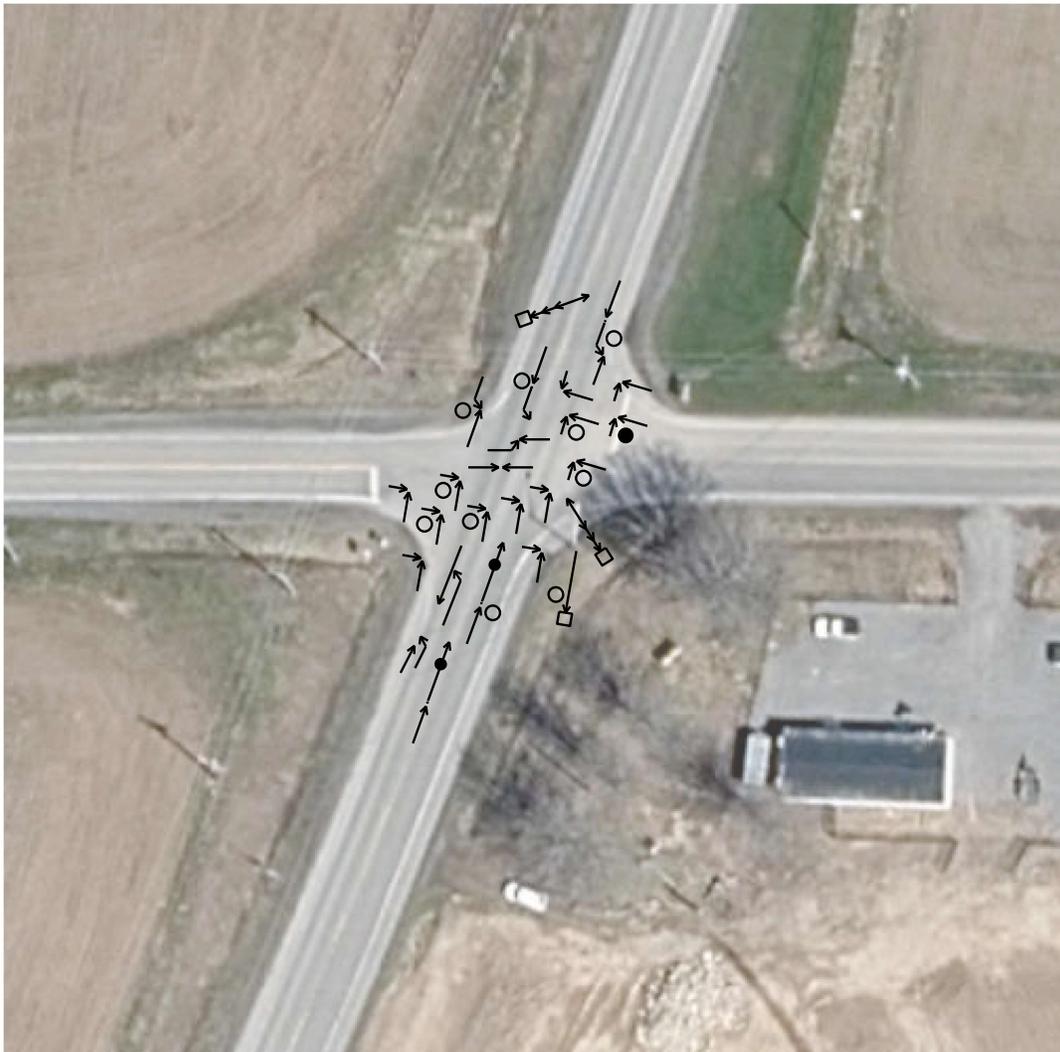
A ten-year and three-month crash history was obtained for the intersection of Rt. 77 & Indian Falls Rd. The crashes were plotted on an aerial image to illustrate the crash types using TE-56 from the NYSDOT Crash Analysis Toolbox (**Figure 12**). The crashes are also listed below in **Table 9** to show the crash history since 2012. The crashes are categorized by severity: Injury and/or Fatal, or Property Damage Only. Analysis of the crash data is done to assist in identifying safety enhancements to reduce crashes. The Western New York National Cemetery opened in November of 2020.

DEPARTMENT OF TRANSPORTATION COLLISION DIAGRAM			
MUNICIPALITY	TOWN OF PEMBROKE	COUNTY	GENESEE
INTERSECTION	ROUTE 77 @ INDIAN FALLS RD		
PERIOD	10 YR 3 MO	FROM	01 / 01 / 2012 TO 04 / 03 / 2022
		FILE	NYS DOT Crash Analysis Toolbox
		BY	LNS DATE 04 / 08 / 2022

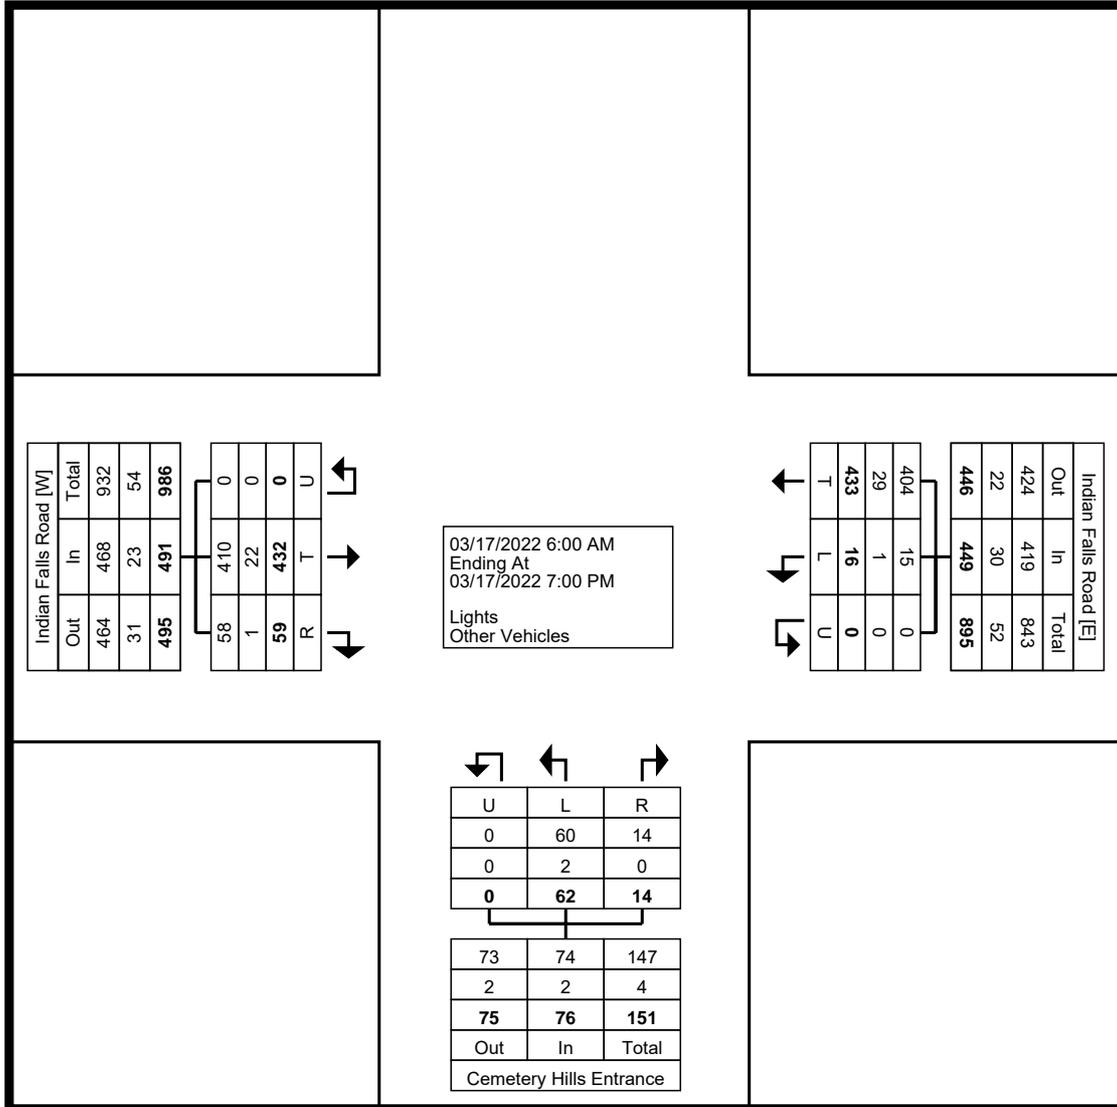
Turning Movement Data Plot

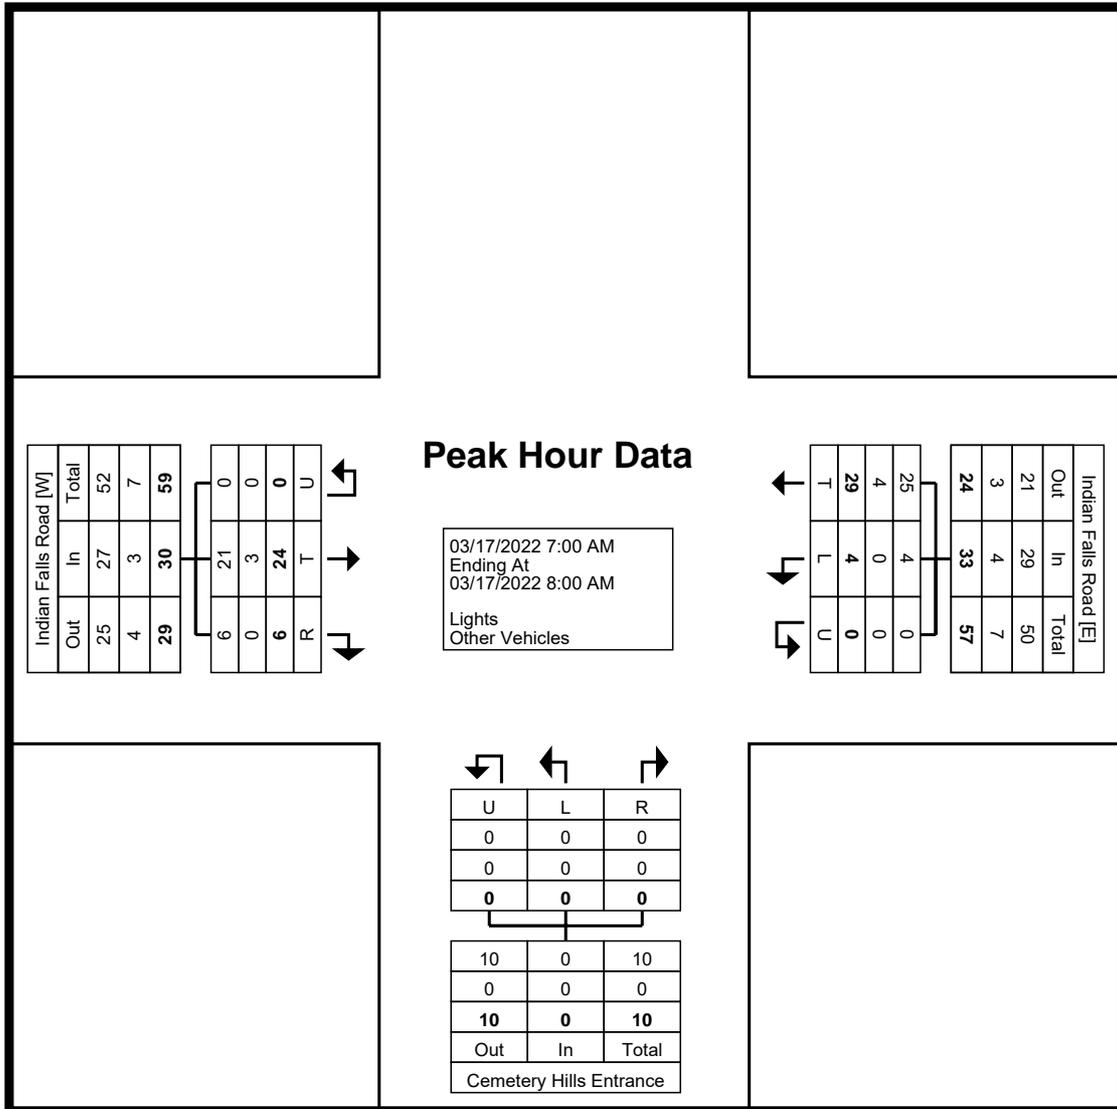
Turning Movement Peak Hour Data Plot (7:00 AM)

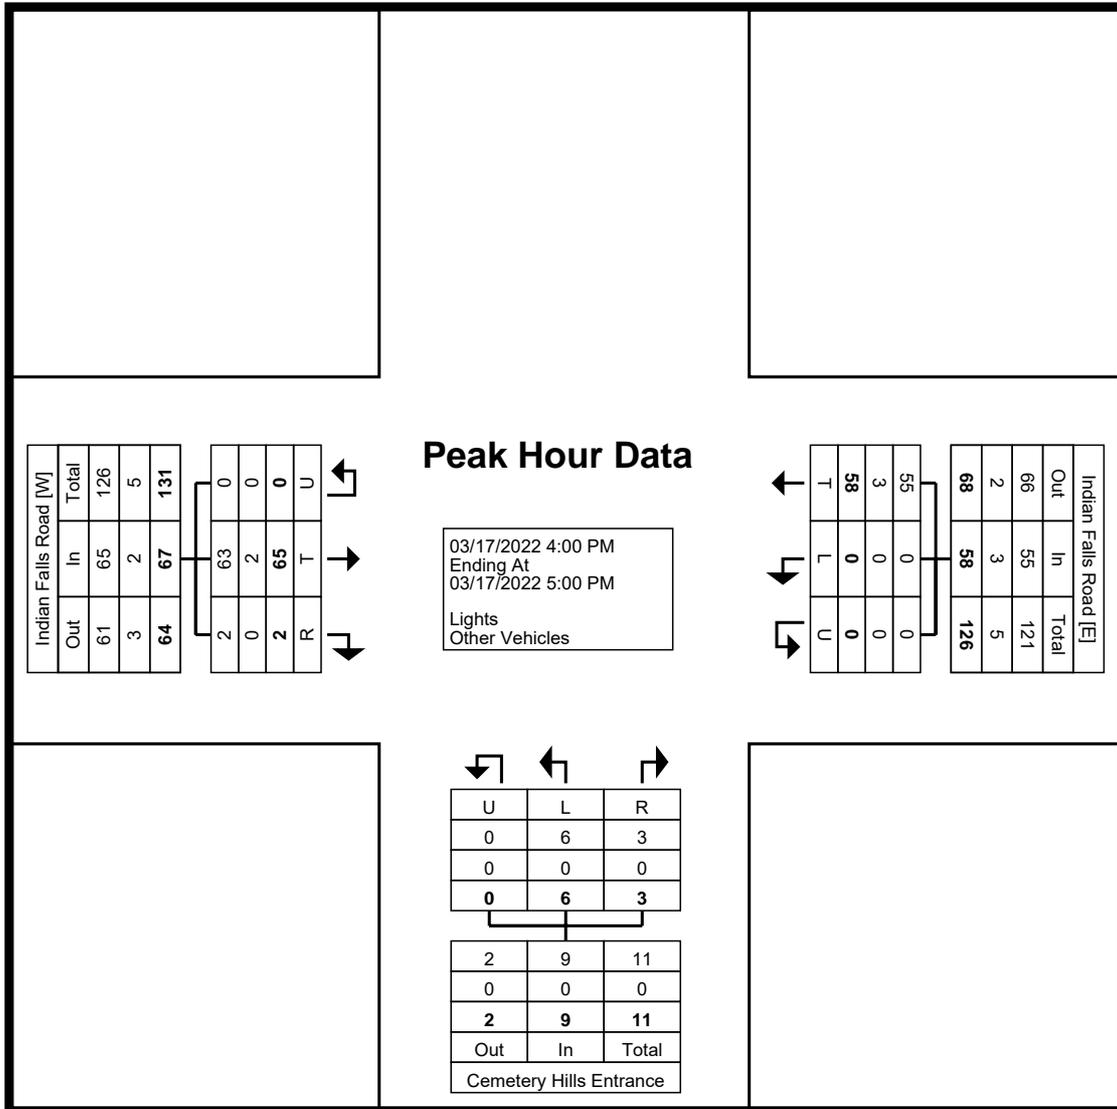
Turning Movement Peak Hour Data Plot (4:00 PM)

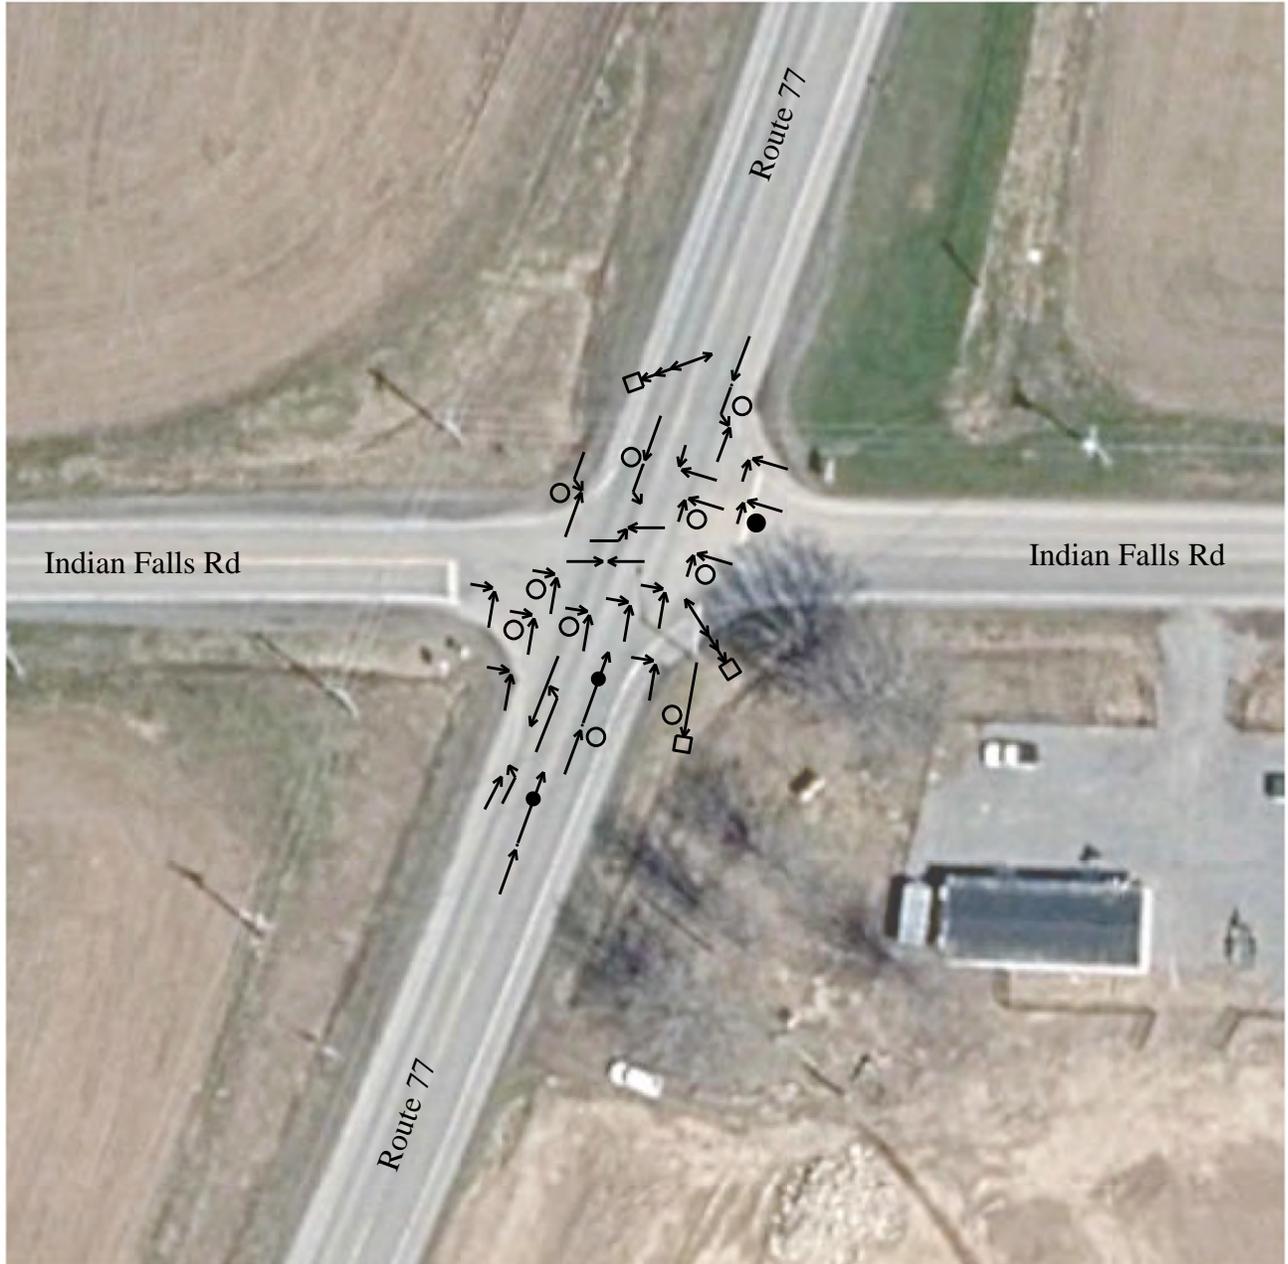
MUNICIPALITY	TOWN OF PEMBROKE	COUNTY	GENESEE	FILE	_____					
INTERSECTION	ROUTE 77 @ INDIAN FALLS RD									
PERIOD	YR	MO	FROM	01 / 01 / 2012	TO	04 / 03 / 2022	BY	LNS	DATE	04 / 08 / 2022
