CONSULTANT			ARCHITECT/ENGINEER OF RECORD		STAMP	Office of Construction and Facilities Management		Drawing Title LANDSCAPE PLAN		Phase CONSTRUCTION DOCUMENTS 1	Project Title HOUSTON NATIONAL CEMETERY PHASE 5 DEVELOPMENT		Project Number 851PC2048	
	The LA Group (518) 587-8100	Aqua Engineering, Inc. (970) 372-6104	OCMI (202) 607-7575

CONSULTANT		ARCHITECT/ENGINEER OF RECORD		STAMP	Office of Construction and Facilities Management		Drawing Title LANDSCAPE PLAN	Phase CONSTRUCTION DOCUMENTS 1	Project Title HOUSTON NATIONAL CEMETERY PHASE 5 DEVELOPMENT	Project Number 851PC2048
		The LA Group (518) 587-8100	Aqua Engineering, Inc. (970) 372-6104	Gordon			U.S. Department of Veterans Affairs		Approved: Project Director		HARRIS COUNTY, TEXAS	Building Number
		RVi (512) 480-0032	AES Group (303) 841-3922	148 S. Queen Street, Suite 201 Martinsburg, WV 25401 Phone: 304-725-8456 www.gordon.us.com							Location	Drawing Number
		Komatsu Inc. (817) 587-8100	ECS Midwest LLC. 847-279-0366	PROGRAMMING AND PLANNING CIVIL ENGINEERING LANDSCAPE ARCHITECTURE SURVEY AND MAPPING SECURITY CONSULTING							Issue Date August 30, 2019	L-103
											Checked MS	Dwg. 134 of 205
											Drawn AC, LI

The goals

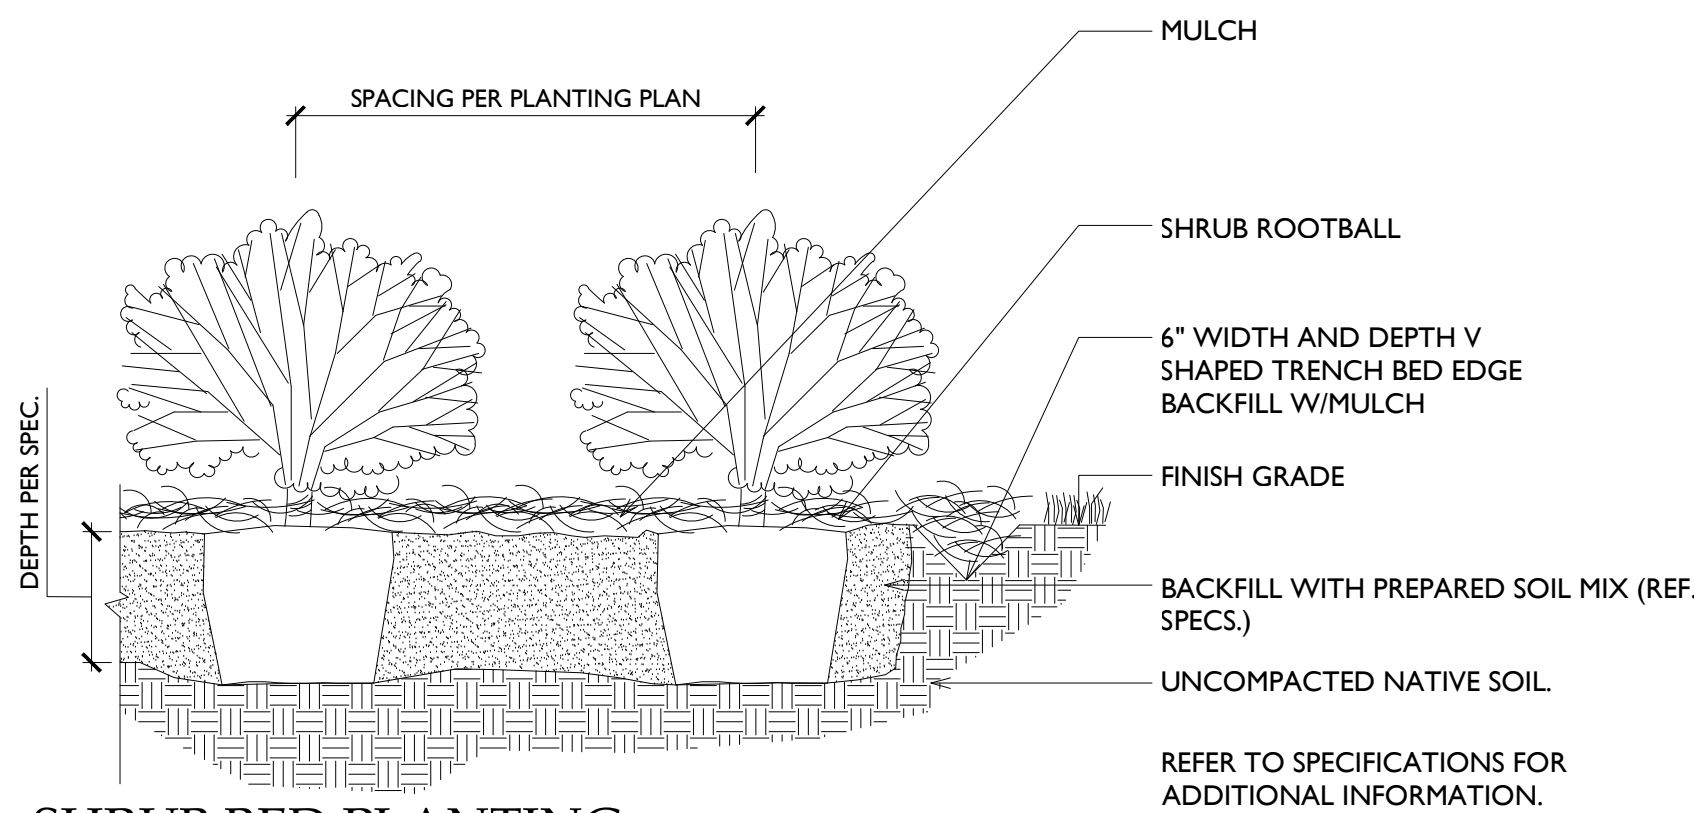
SHRUB BED PLANTING

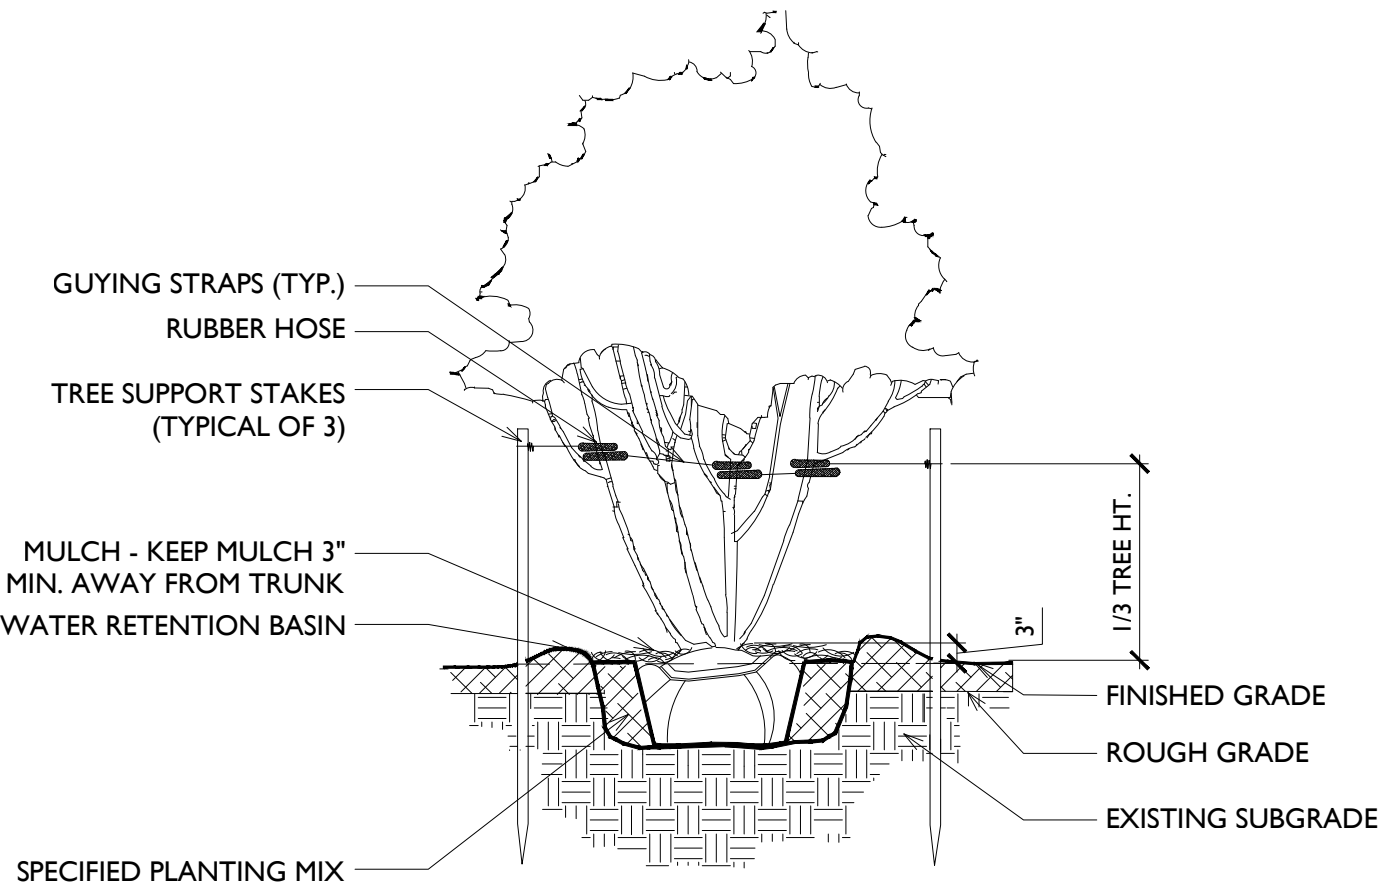
MULTI-TRUNK TREE PLANTING

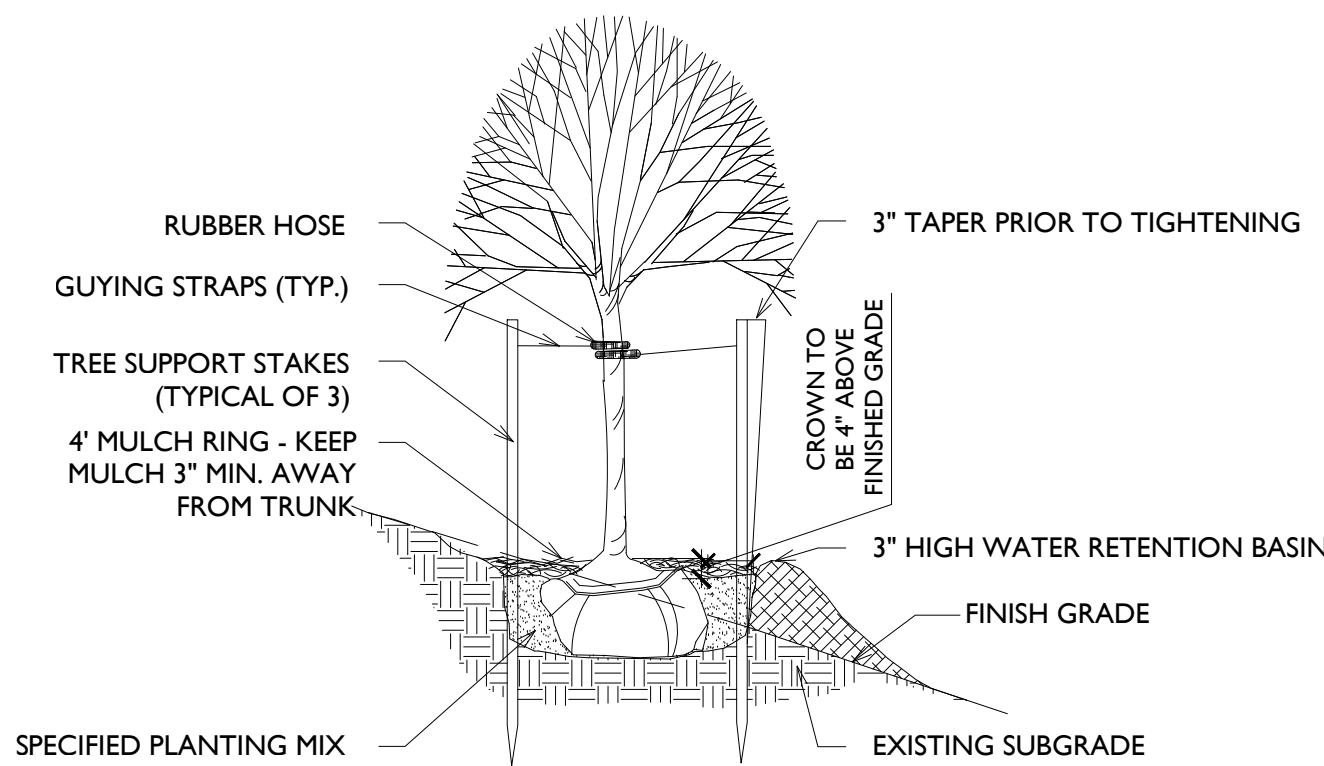
SLOPE TREE PLANTING

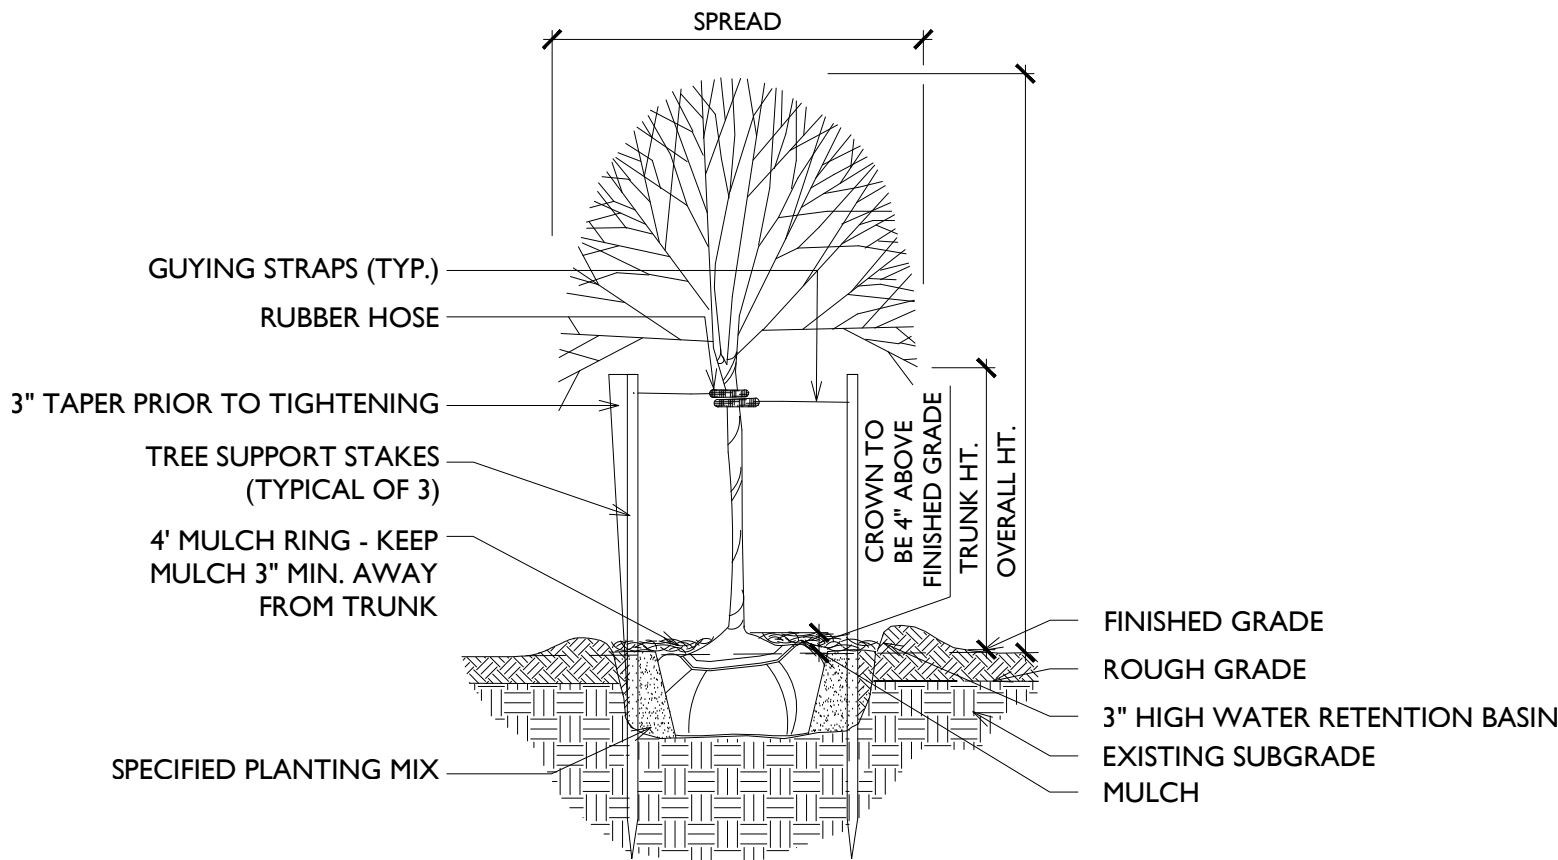
TREE PLANTING

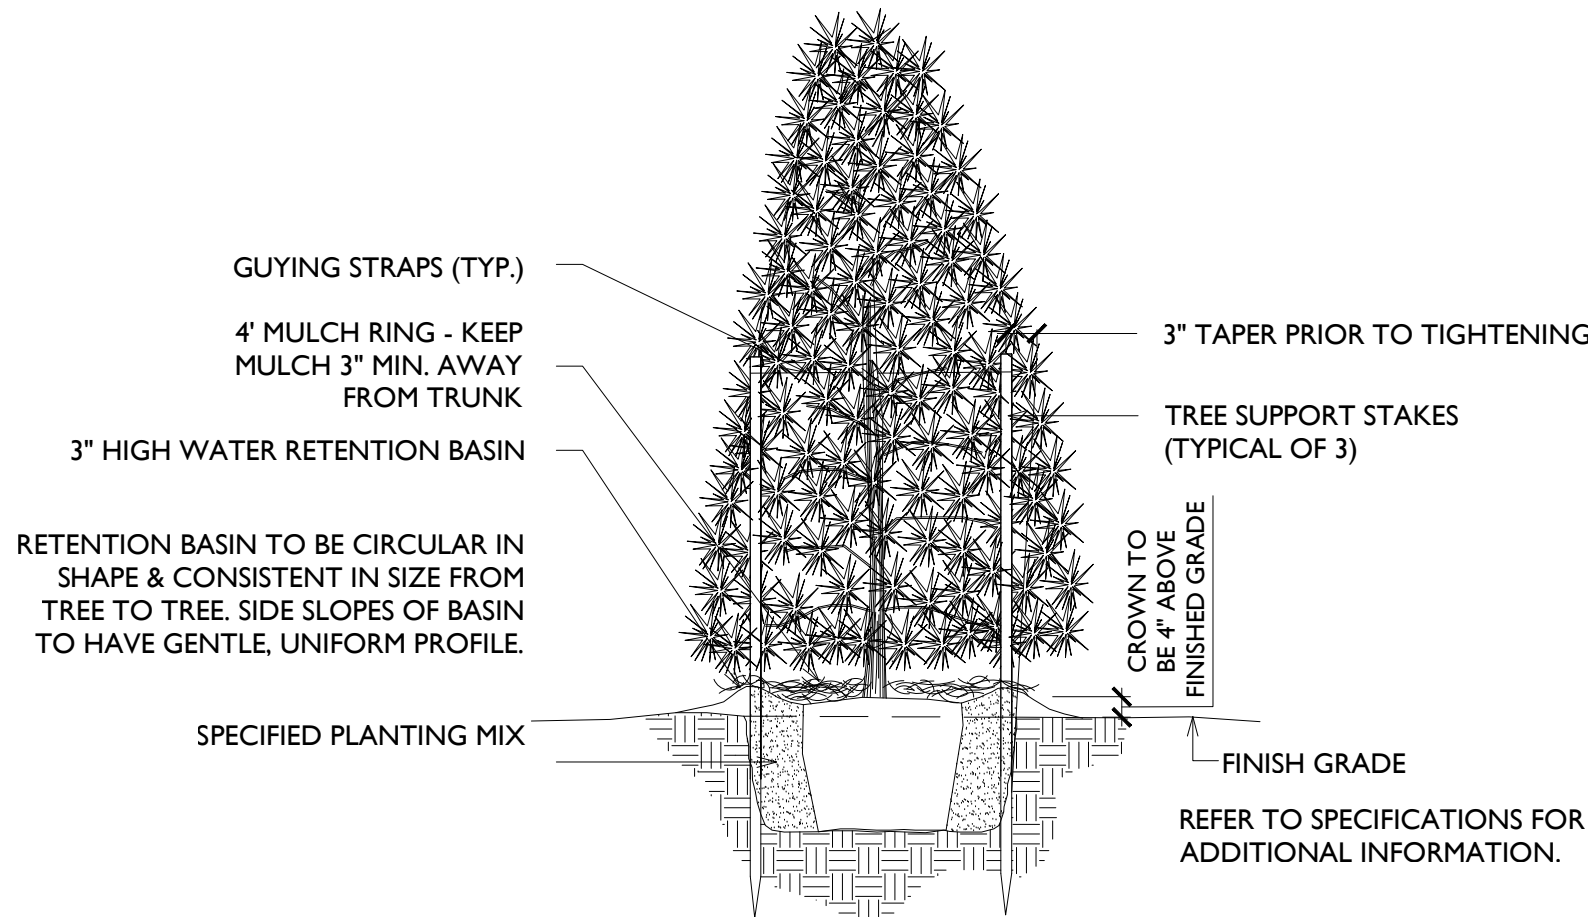
EVERGREEN TREE PLANTING

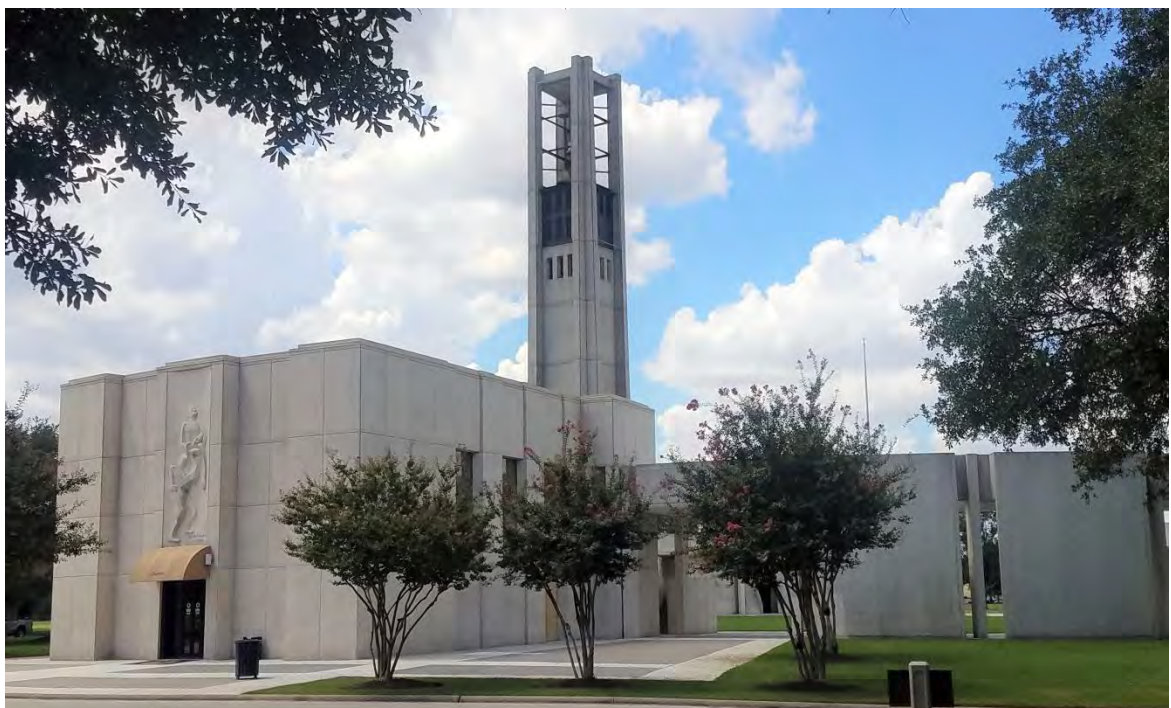
Figure 2 Chapel, North and East Elevations

The double volume Chapel sits as the keystone to the hemicycle where the two halves meet but do not physically touch. It is trapezoidal in form and constructed out of pre-cast concrete panels with an exposed quartz aggregate finish, similar to the hemicycle. The main elevation is host to a 20 feet by 6 feet sculptural panel. It is mostly original in form besides a couple of interior renovations, one in the 1980s that altered the restroom layouts and introduced a janitor’s closet and in 1996 where the interior was refurbished and the original terrazzo floors were covered in carpet.

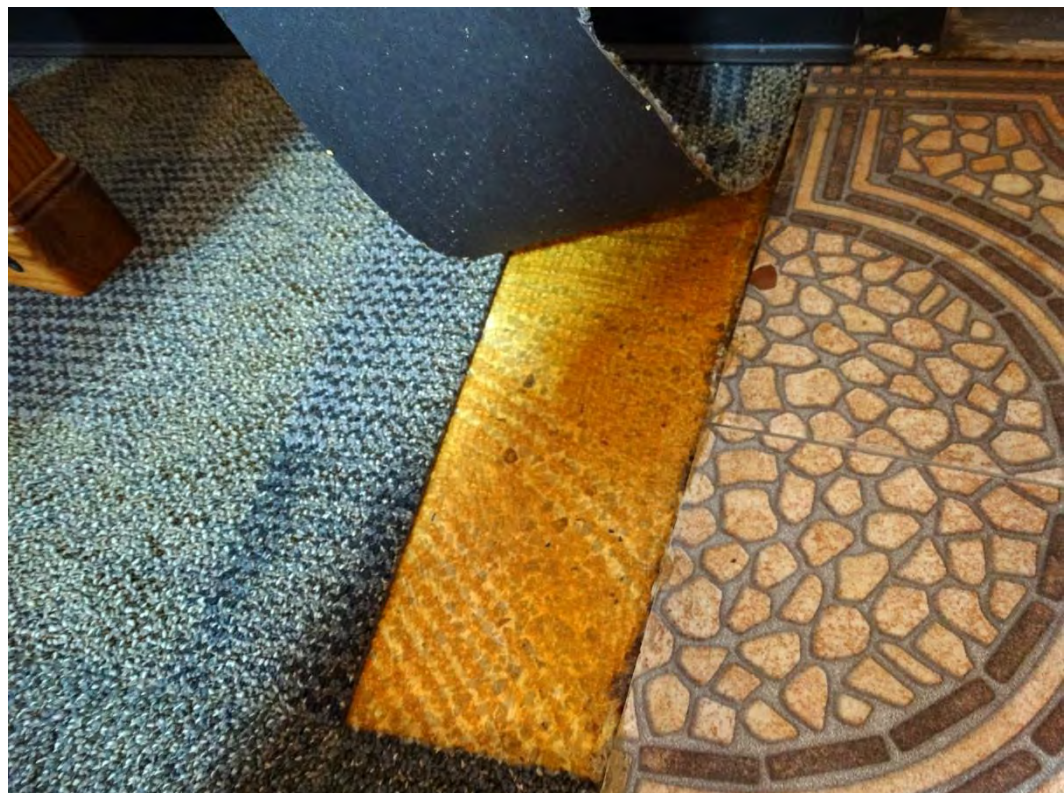
Figure 3 Existing Terrazzo beneath Carpet Tiles

The interior should be completely rehabilitated pursuant to 36 CFR 67. Clean all marble wall paneling and inspect for any cracking, repair if needed and re-grout joints if needed. Clean all wood paneling and vertical battens refinish to match original finish and color. Stain and seal existing double wood door at vestibule to match adjacent paneling. Remove all carpeting throughout to expose existing terrazzo floors. Strip, clean and make all necessary repairs to terrazzo floors before refinishing. If it is discovered that restoring the terrazzo floors is not feasible in the project due to cost restraints, then an alternate carpet will be installed to replace the existing. However, the carpet will not be attached with an irreversible adhesive to allow for potential removal in the future if funding is available for terrazzo restoration.

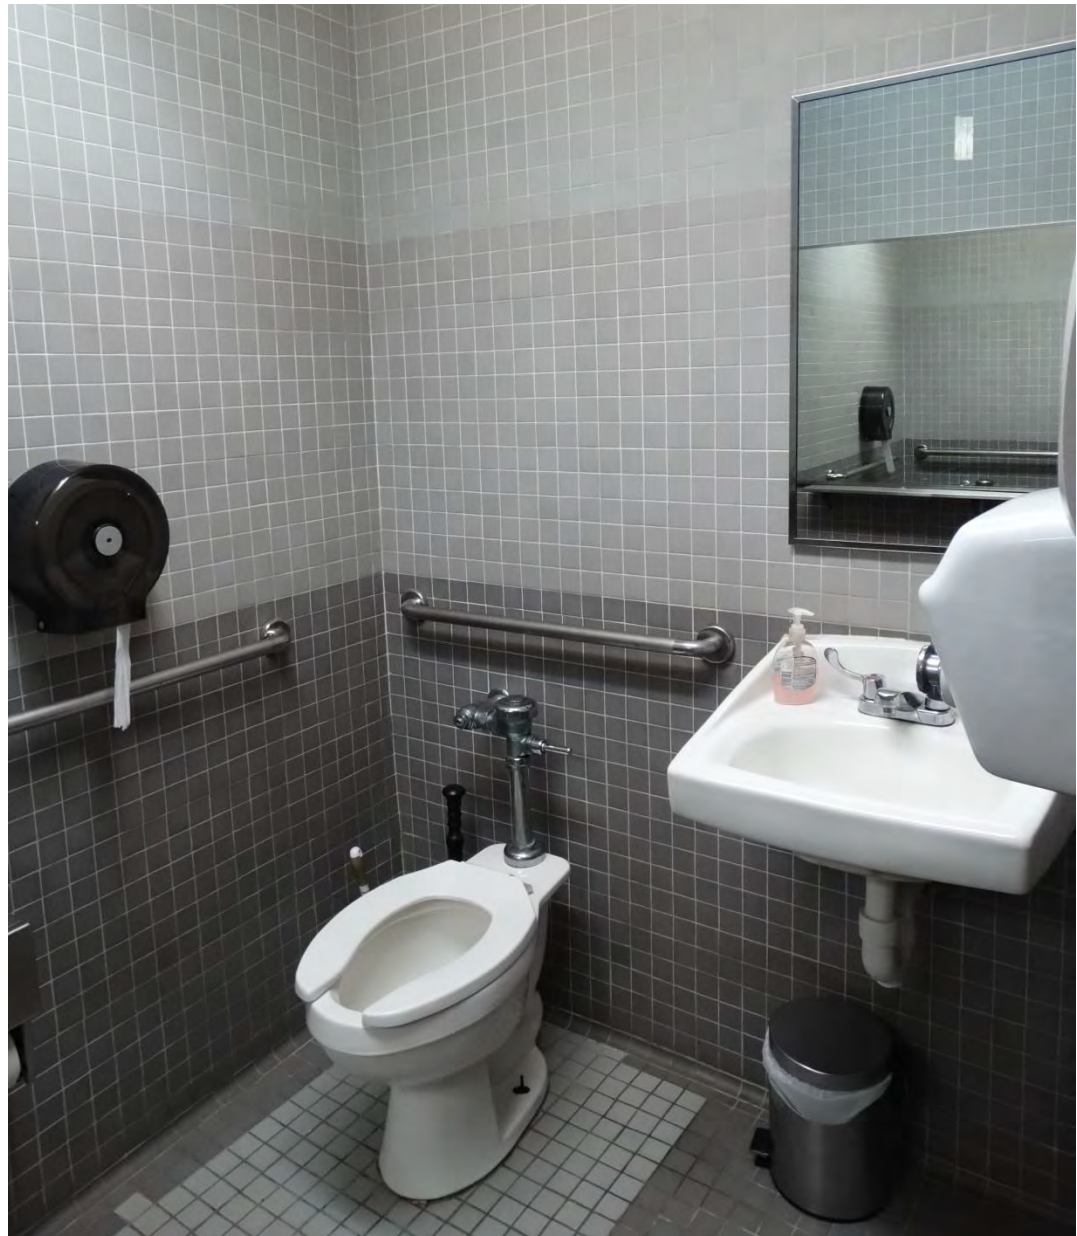
Figure 4 Existing Restroom to be refinished

All existing plaster surfaces should be repainted to match existing, inspect all plaster for any deterioration or damage including ceilings and make all necessary repairs. Upon our inspection there was no damage noted in the existing plaster work. The single user restroom should be completely renovated to comply with accessibility standards. All new fixtures, replace existing lay-in ceiling with a hard gypsum ceiling and all new finishes.

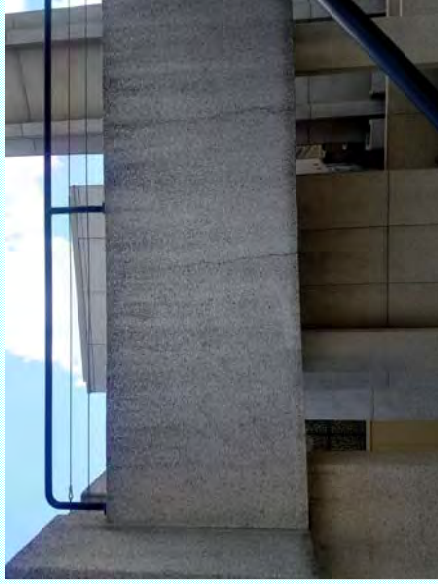
Photo: A—Vertical cracks in stair openings

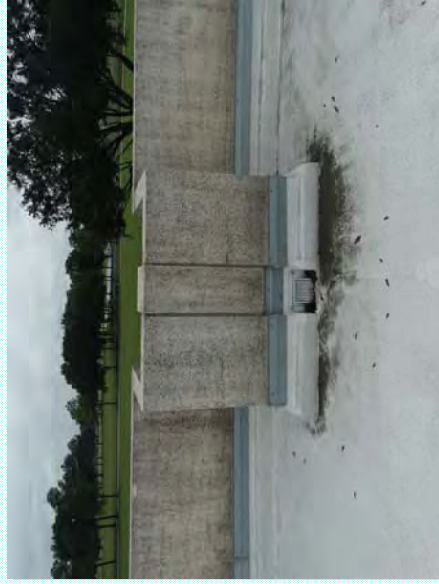
Photo: C—Biological staining on the inside of the upper panels

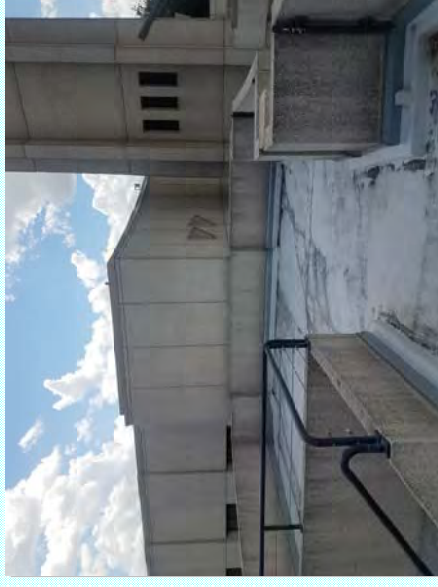
Photo: B—Biological settlement on upper deck along the perimeter

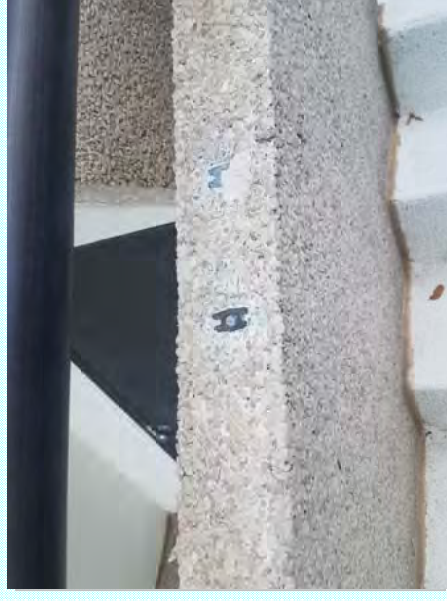
Photo: D—Exposed steel fasteners at the top of upper panels

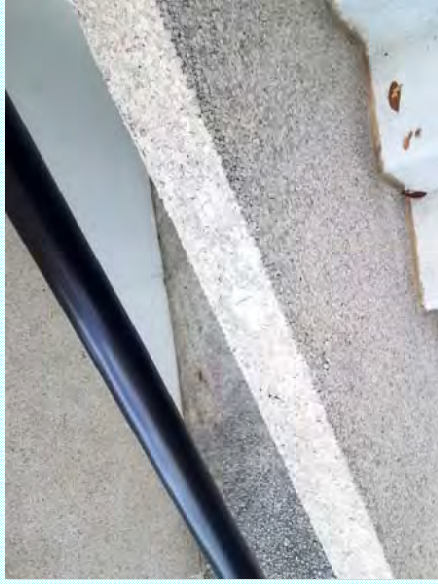
Photo: E—Previous patchwork cracking

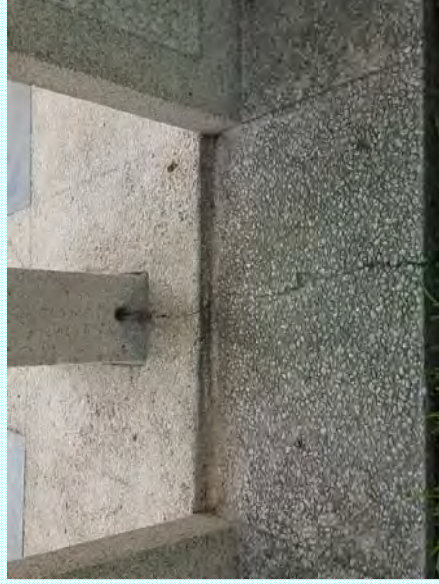
Photo: G—Flatwork cracking and spalling at the outside columns

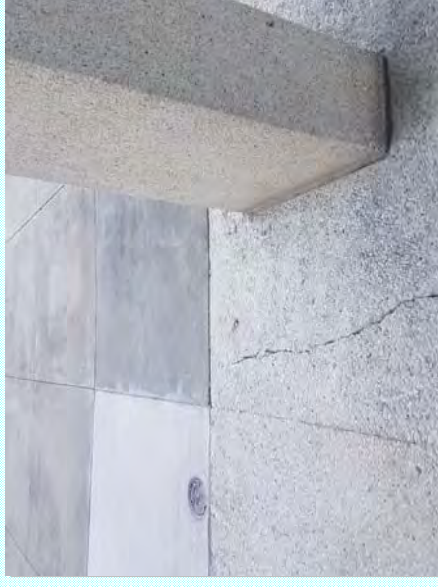
Photo: F—Flatwork cracking adjacent to inside columns

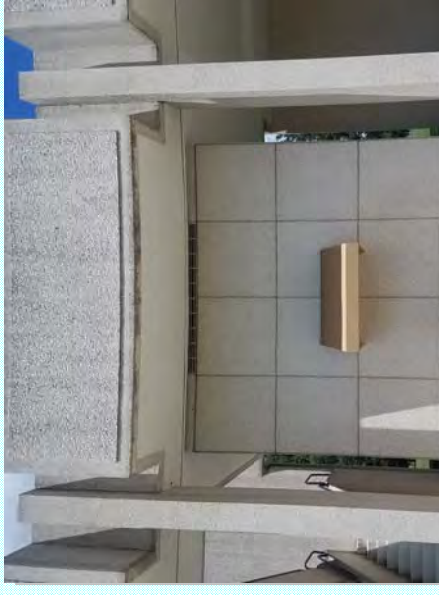
Photo: H—Staining at the bottom of the upper panels
